**CROSSWALK
EVALUATION**

FRUITA TRAFFIC COMMITTEE

December 2018

FRUITA
COLORADO

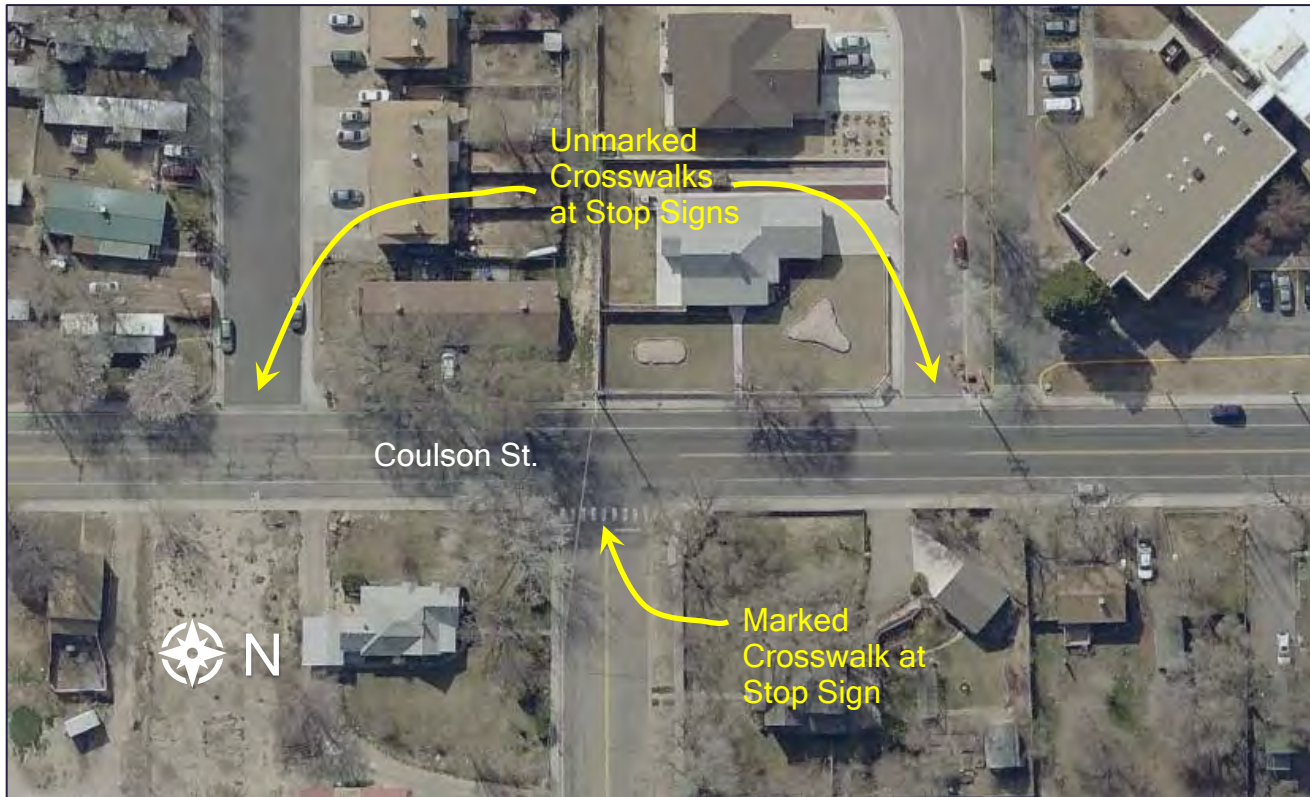
Figure 1: Example of Crosswalks at Intersecting Roads

The majority of the crosswalks in Fruita are located at stop-controlled intersections. This includes a number of crosswalks across streets intersecting with collector roadways, but it does not appear to be consistent and it is unclear how some of the locations were determined necessary for marked crossing (see example in Figure 1). In general, the stop-controlled crossing locations appear to have appropriate pavement markings and signage, and provide safe opportunities for pedestrians to cross. Even crossing at unmarked locations with stop-

control provides for relatively safe crossing options for pedestrians. This study does not include evaluation of stop-controlled crossings and focused more on areas that may require additional crossing treatments to improve safety. Additional measures at stop-controlled intersections may need to be considered if concerns exist with driver compliance, accident history, or longer crossing lengths.

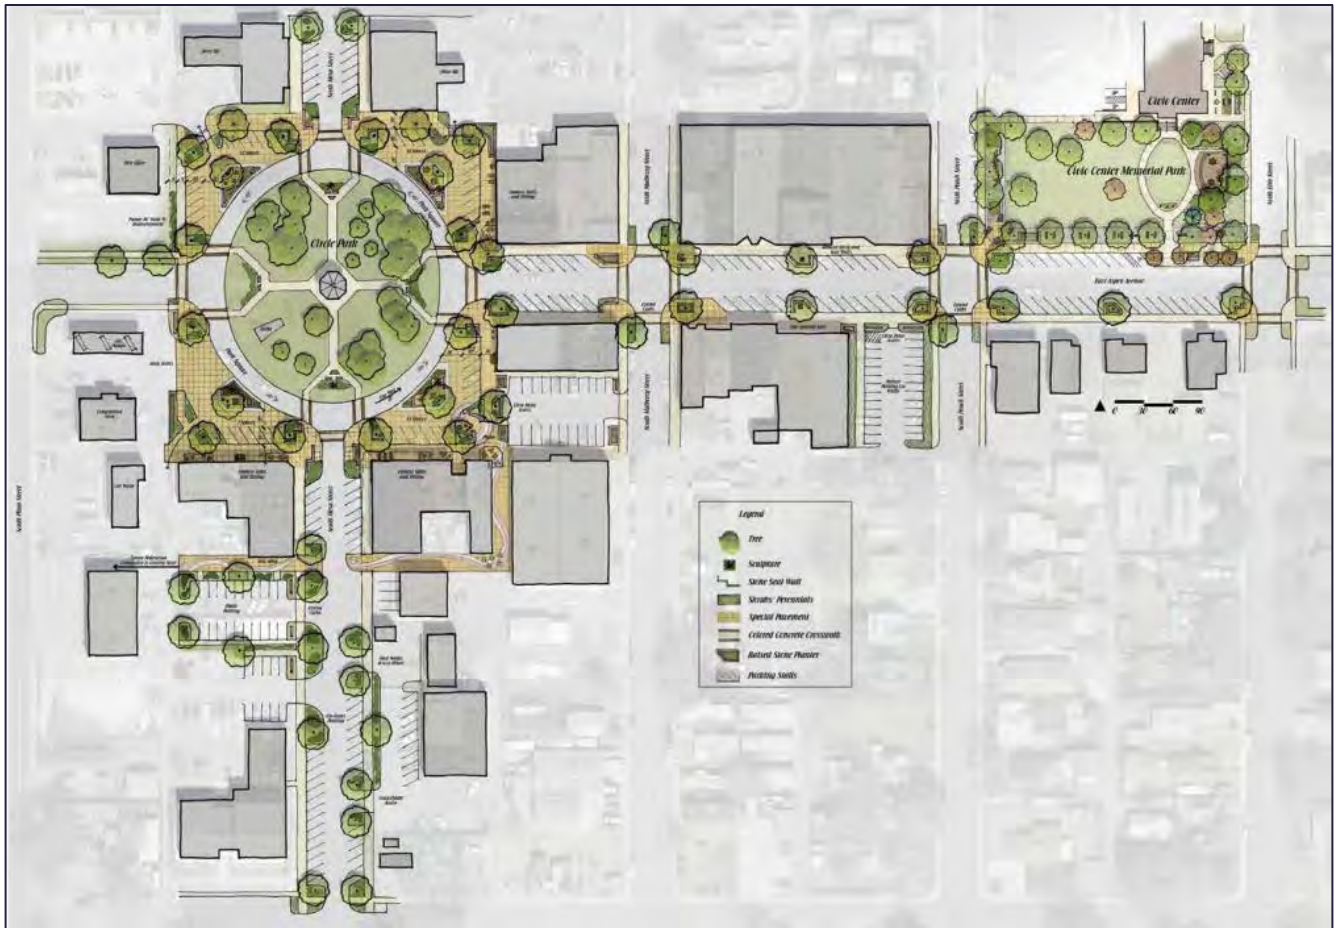
Figure 5: Concept from 2013 Downtown Streetscape Improvements Plan

The City adopted a master plan for streetscape improvements in the downtown area in 2013. This document provides specific guidance on pedestrian traffic functions and recommended improvements, which includes the importance of traffic calming and crosswalks. The first phase of implementing the recommended improvements was completed on Aspen Avenue at the Peach Street and Mulberry Street intersections. Future streetscape improvements will further incorporate the recommendations from the downtown master plan, but in the mean time there

are a few areas with potential safety concerns that may need to be prioritized sooner. There are also some areas just outside the limits of the study that should be evaluated further.

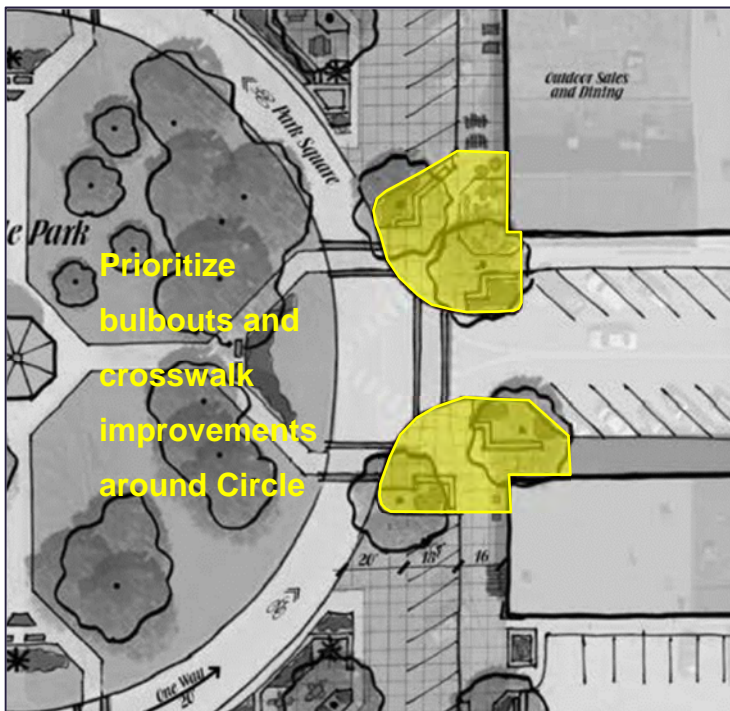
Figure 7: Concept for Crosswalk Improvements at Circle

The existing crosswalks at the intersections around the Circle pose considerable challenges for pedestrians crossing, especially from the center outward. These crosswalks around the Circle are recommended to be relocated with future streetscape improvements to shorten the crossing lengths as part of additional traffic calming features. However, the cost of the streetscape improvements around the Circle is quite high (estimated at over \$2.5 million in 2013) and are not currently included in capital plans for at least 10 years. It is

recommended that the intersection bulbouts around the Circle be prioritized in advance of the parking courts and other Park Square improvements to address some of the safety issues associated with the crosswalks sooner.

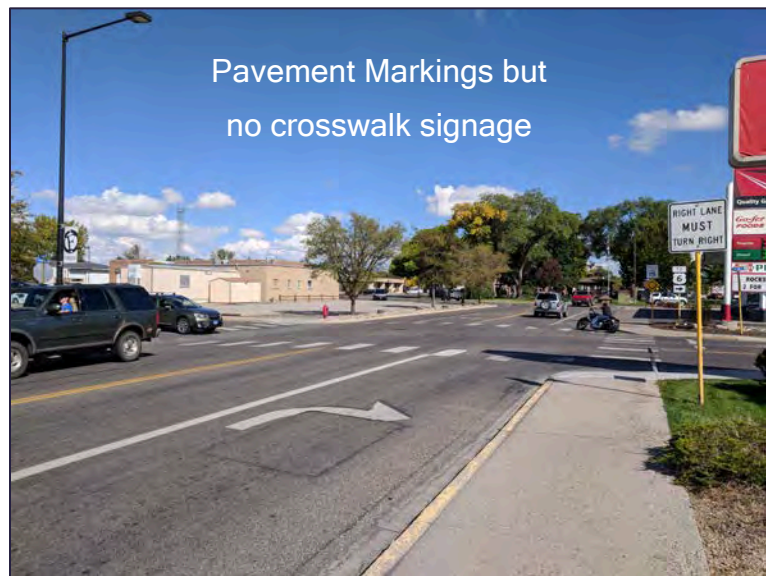
Figure 8: Aspen Avenue at Plum Street

The Plum Street intersection also does not have stop control and has higher volumes of vehicular traffic than further east. This intersection is also just beyond the limits of the downtown master plan and lacks the guidance on traffic calming measures. As such, it should be noted that the crosswalks on Aspen Avenue at Plum Street should be characterized as a high priority for

safety improvements. This intersection currently has crosswalk bar pavement markings but does not have any type of basic crosswalk signage. This may be in part due to the fact that the area is already congested with other roadway signage due to its close proximity to the traffic signal at Cherry Street, individual property access points, and highway access signs. Some solutions might include installing geometric improvements to reduce the crossing lengths, installing additional signage, or eliminating some of the vehicular access points along this section of Aspen Avenue. Any geometric changes would need to be coordinated with the Colorado Department of Transportation to accommodate traffic from the west, with the downtown master plan to the east, and with the business owners in the immediate vicinity. This evaluation did not include any public outreach or interagency coordination related to this area and recommends that this be completed prior to making any changes.

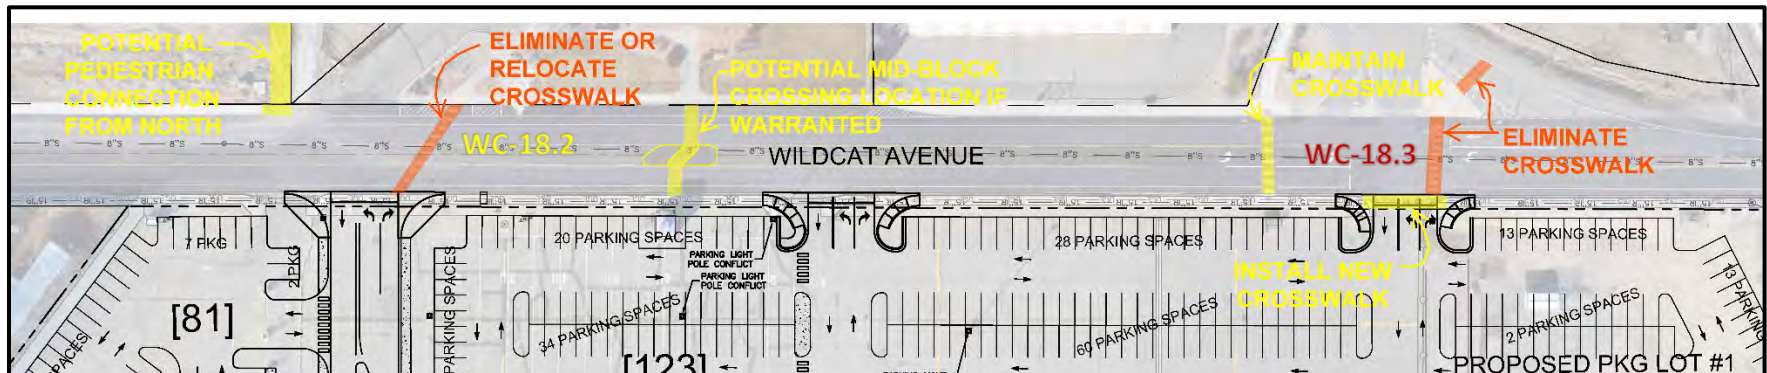
LOCATION: Wildcat Avenue @ FMHS

VEHICULAR TRAFFIC: 2,344 ADT & 387 VPH

POSTED SPEED: 35 MPH (20 MPH when flashing)

ROAD CONFIGURATION: 3 Lane w/ Striped Median

Figure represents potential changes based on planned access locations being considered by School District No. 51.

Crossing ID	Crossing Location	Crossing Type	Near-term Action
WC-18.2	Fruita Monument High School	Type C Enhanced	Consider eliminating and route pedestrians to J.3 Road, or Relocate to location where pedestrian refuge island may be feasible.
WC-18.3	J.3 Road	Stop Control	Eastern crossing does not connect to any existing pedestrian facilities. Evaluate if eastern crosswalk is needed.

To improve the safety for pedestrians along Wildcat Avenue, it is recommended that the priority be to reduce the number of crosswalks, if possible. Crosswalks located at uncontrolled locations should be eliminated first and students should be directed to stop controlled intersections when able. Eliminating crosswalks will require further coordination with the individual schools and should also require some crosswalk education for the students. Some potential changes that might be able to be incorporated as part of future access changes planned by FMHS are included in Appendix B on Page 4.
