**GEOTECHNICAL AND GEOLOGIC HAZARDS  
INVESTIGATION  
19 ROAD IMPROVEMENTS  
FRUITA, COLORADO  
PROJECT#00207-0017**

**CITY OF FRUITA  
325 E. ASPEN, SUITE 155  
FRUITA, COLORADO 81521**

**FEBRUARY 8, 2024**

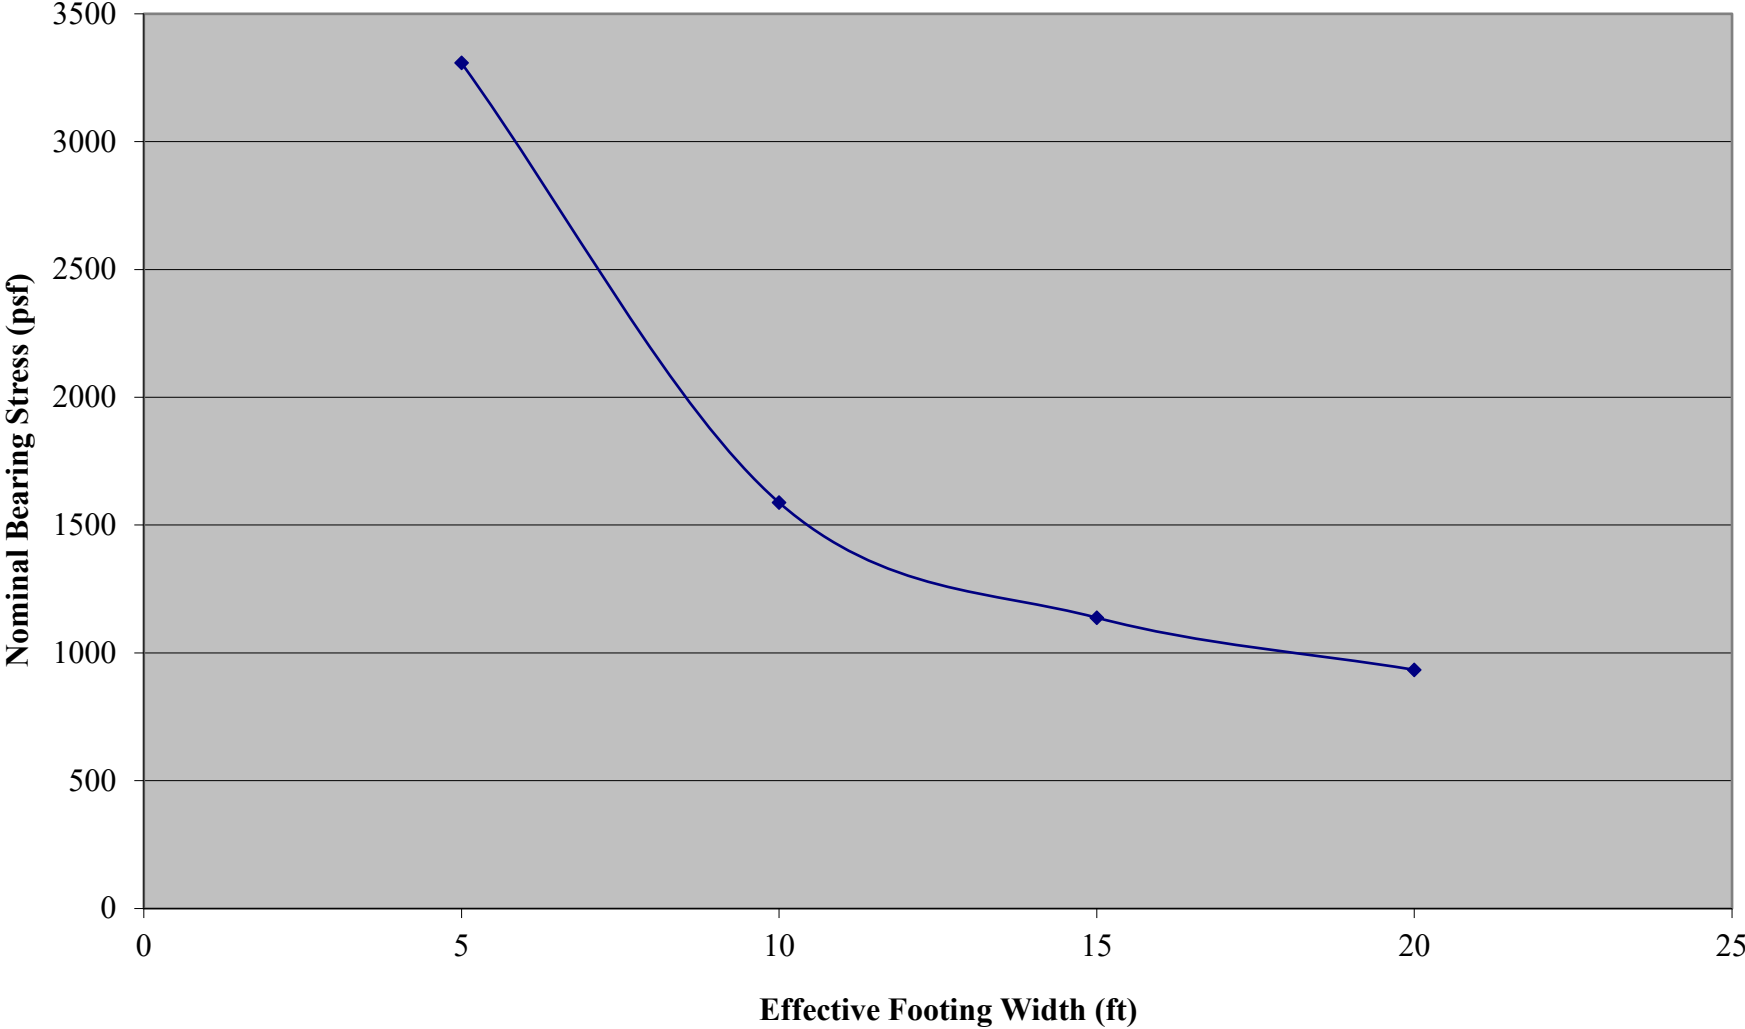
**APPENDIX D**  
**Bearing Resistance for Service Limit State**

# LRFD Service Limit State
